# BELZONA ATTENTION ON THE ROOF

ID: 172

## PROBLEM

This building had been renovated, severe leaks were destroying new ceiling tiles and wallpaper. Flashings were pulled away from the wall and water gushed in.

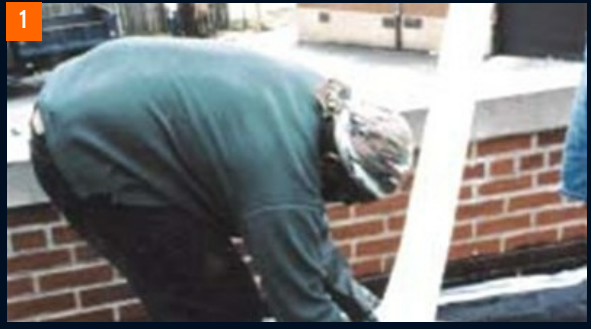
1. Belzona 9311 (Membrane Reinforcing sheet) is pre-wetted prior to application.
2. Second coat of Belzona 3111 (Flexible Membrane) over first.
3. The finishing touches.
