# BELZONA BONDS PIPE SUPPORTS TO TANK

ID: 1720

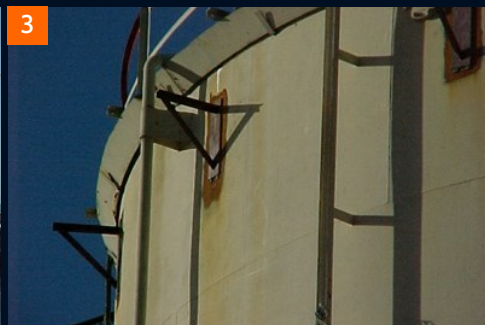
1. Tank Farm Location
2. Tank Farm Location
3. Close up showing the bracket bonded. The rust was due to the later coating of the tank/bracket
4. Additional view of bonded brackets

Application was carried out using a modified version of Belzona System Leaflet VPF-15. The surfaces were prepared by gritblasting using a water/amine fire suppressant and corrosion inhibitor (approved for use). The supports were bonded to the tank sides.
