# BELZONA CHILLER

## PROBLEM

York chiller condenser

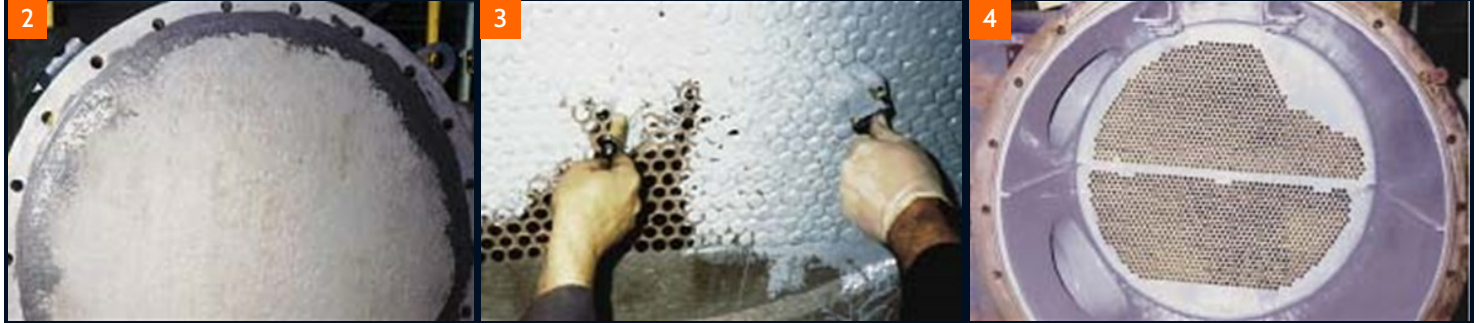
## PHOTOS

Corrosion problems were beginning on the tube sheet and end covers.

1. Divider plate removed exposing corrosion on the tube sheet and water box.
2. Belzona 1121 (Super XL Metal) was applied to repair perimeter of cover plate.
3. First coat of Belzona 1341 (Supermetalglide) on tube sheet face in progress.
4. Completed chiller condenser.

The application was carried out in accordance with Belzona Know-How Leaflets HEX-1, HEX-2, and HEX-3.

Rebuilding the covers prevented the seal area from leaking. A total of five chillers have been successfully coated with Belzona, and the contractor, Scherer, will be coating six more chillers to extend the life of the tube sheets and end covers.
