# BELZONA REPAIRS A FRANCIS TURBINE

ID: 1736

Hydroelectric power plant / Moulin Neuf, France

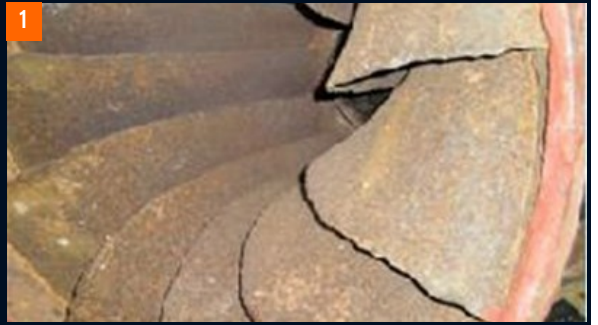
This turbine was in operation since 1976 and showed significant erosion-corrosion.

Original turbine After disassembling  
After rebuilding with Belzona 1311  
Application of 2 coats of Belzona 1321
