# BELZONA LEAD CHAPEL ROOF

ID: 175

## PROBLEM

Deteriorating lead roof required long-term protection.

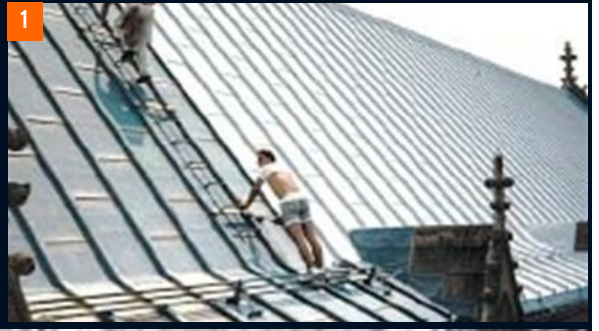
1. Belzona 3111 (Flexible Membrane) applied to the right, Belzona 3921 (GSC Surface Conditioner) being applied at left, uncoated section lower left.
2. Work continues at the apex.
3. Front view of the chapel, lead roof protected.

Application was carried out in accordance with a modified version of Belzona Know-How Leaflet RPA-1.

Belzona 3111 (Flexible Membrane)  
Belzona 3921 (GSC Surface Conditioner)  
Belzona 9311 (Membrane Reinforcing Sheet)

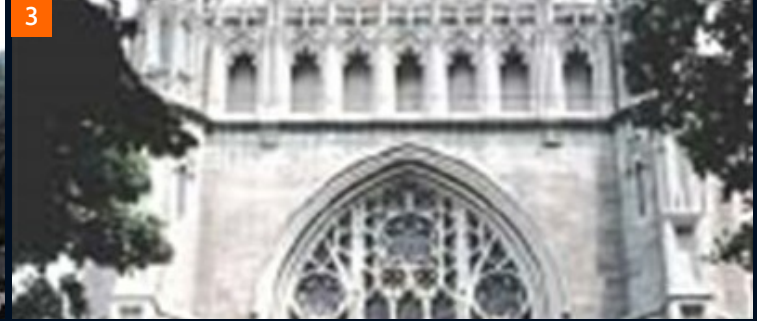
This 70-year-old roof had experienced deterioration over the years due to atmospheric conditions. The university was considering replacement, however, due to the prestigious work that was done on the lead roofs of the House of Lords in the U.K., Belzona was chosen for this project and extended the life of the lead roof.
