# BELZONA STAIRWELL MADE SAFE

Stairwell for Navy V.I.P. entrance

U.S. Naval Base in South Mississippi, U.S.A.

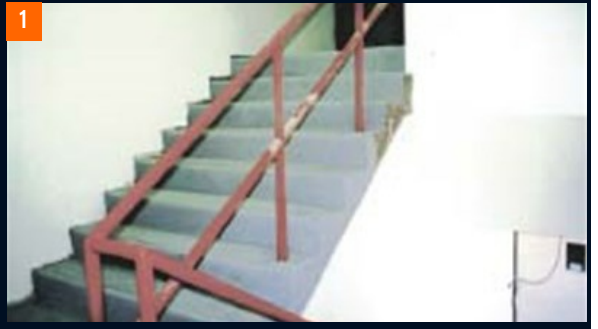
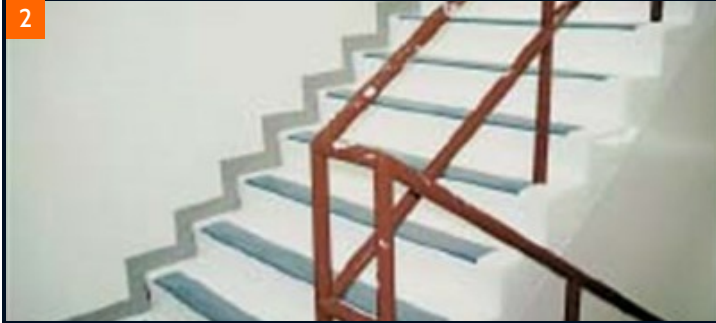
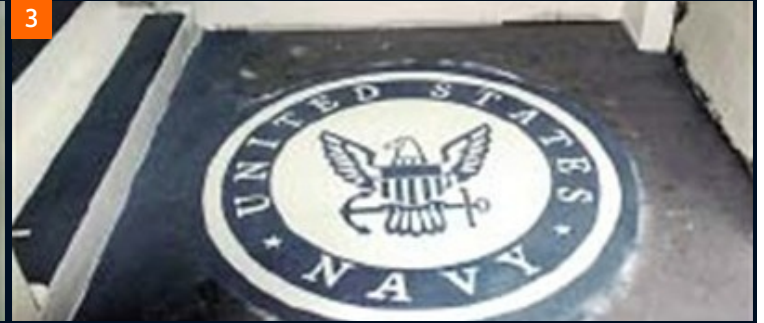
Stairs were spalled and deteriorated and required a non-slip safety surface.

1. Steps resurfaced with Belzona 4131 (Magma Screed).
2. Belzona 5111 (Ceramic Cladding) applied for aesthetic reasons, and Belzona 1341 (Supermetalgilde) grip system applied primarily for safety reasons.
3. At the foot of the stairs, the non-slip Navy logo was created with a stencil.

Application was carried out in accordance with Belzona Know-How Leaflets FPA-1 and FPA-8.

Belzona 1341 (Supermetalgilde)  
Belzona 4131 (Magma Screed)  
Belzona 4911 (Magma TX Conditioner)  
Belzona 5111 (Ceramic Cladding)  
Belzona 9221 (Surefoot Aggregate White)
