# BELZONA CONCRETE COOLING TOWER BASINS

ID: 177

Cooling tower basins required protection

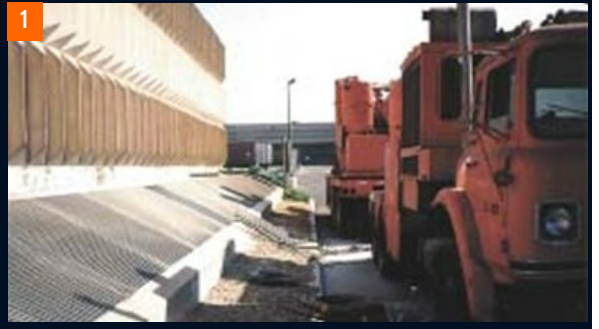
Basins were deteriorated due to attack from chemically treated water. Left unchecked the concrete would continue to degrade and eventually result in leakage.

1. Outside view of the tower, drainage and clean-up begins.
2. Coating inside the basin commences.
3. The completed job, concrete sealed and protected.
