# BELZONA SEALANT FOR METHANE POWERED ENGINE PAD

ID: 178

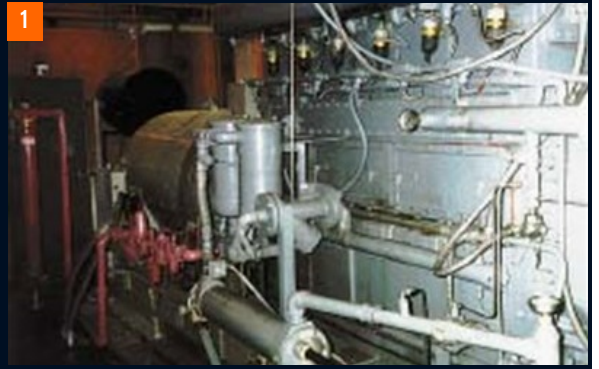
1. View of the engines used at wastewater plant. Three engines are located in powerhouse.
2. Old cork removed and new backer rod installed.
3. Finished application, Belzona 2221 ready to handle vibration.

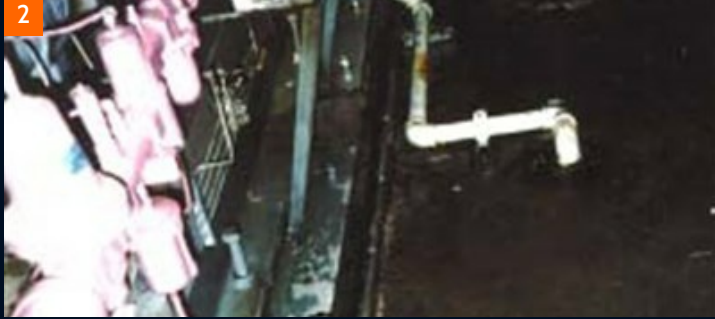
Old cork expansion joint material hardened, allowing vibration to crack the floor outside of the joint area.
