# BELZONA REFURBISHMENT OF AFTERCOOLER HEADS

ID: 179

Seven heads off air compressor aftercoolers

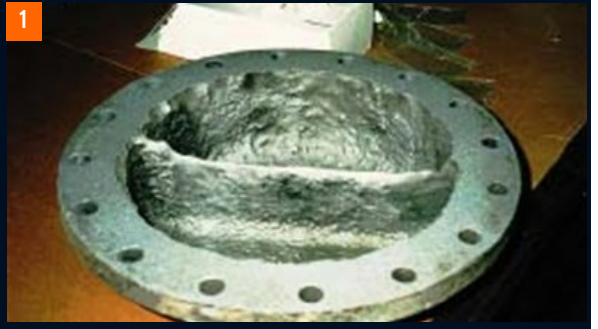
Years of erosion/corrosion had deteriorated the divider bars causing bypass and inefficiency.

1. Grit blasted cover.
2. Formers in place and coated with Belzona 9411. Rebuilding with Belzona 1311 in progress.
3. Rebuilding complete, all parts to be finish coated with Belzona 1321.

All parts were rebuilt with Belzona® 1311 and resurfaced with Belzona® 1321. The cost was \$1,600. All parts are still in use today with no further damage.
