# BELZONA 1591 PROTECTS OIL/GAS SEPARATORS AT HIGH TEMPERATURE

Oil/Gas Test Separator designed to operate up to 150°C.

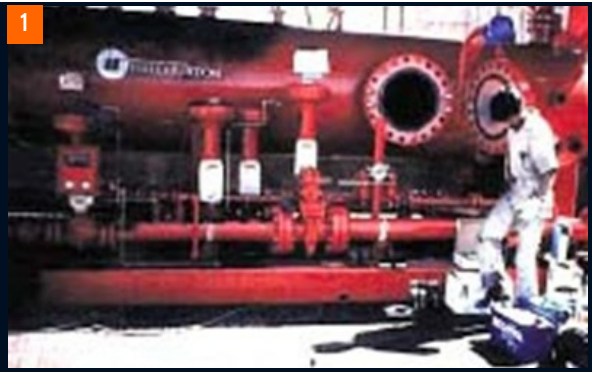
1. General view of separator.
2. Work underway applying Belzona 1591.
3. Final inspection being carried out.
