# BELZONA FABRICATION OF ROTARY LOBES

Rotary pump lobes damaged by entrained solids.

Wemco-muniflo rotary lobe, pump Model RPD5

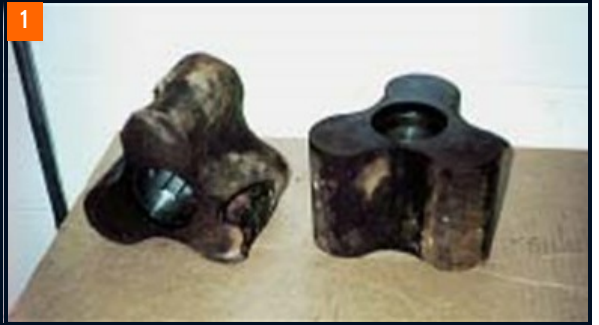
1. Damaged lobes from pump.
2. A perfect mold is made from new lobe using Belzona technique.
3. New lobe casted with Belzona 2131.
4. Inspection six months after installation shows no wear. One year after installation the lobes are operating perfectly.
