# BELZONA RESTORES VALVES TO BETTER THAN NEW CONDITION

Swing pin housings of non-return check valves.

Paper Mill in Northwest Florida, U.S.A.

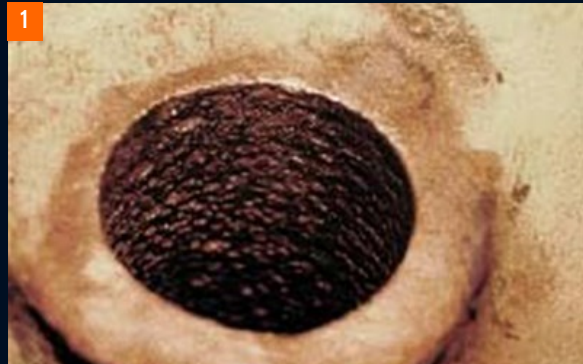
Housing had eroded/corroded to the point where the valve flap would not seat (seal) properly, allowing partial flow in the wrong direction

1. Corroded housing.
2. Molding technique using fabricated dummy pin, Belzona 1111 (Super Metal) and Belzona 9411 (Release Agent) are employed.
3. Finished repair.
