# BELZONA PROTECTS EVAPORATOR TUBE SHEETS

ID: 185

Evaporator tube sheet.

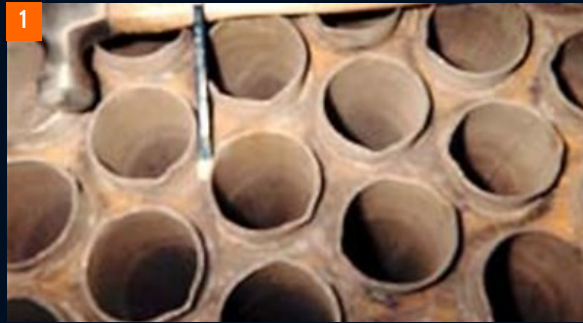
Erosion/corrosion of the tube sheet due to hot caustic (black liquor at 185°F) and galvanic corrosion due to dissimilar metals.

1. Inspection of previous coating shows degradation.
2. One year of Belzona 1391 coating exhibits no signs of degradation.
3. Close-up view. Substrate is protected with Belzona 1391.

The application was carried out in accordance with a modified version of Belzona Know-How Leaflet HEX-1.
