# BELZONA DOES FLOORS

ID: 186

Extreme erosion surrounding drains due to acidic water discharge

Chemical containment floor drainage area

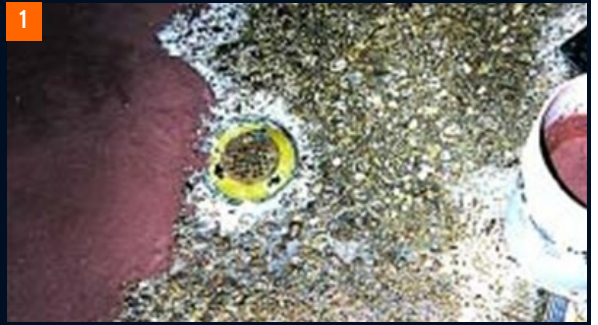
1. Application commences, note the erosion of the concrete drain area.
2. Application proceeds.
3. Finished application, concrete protected and proper drainage restored.

Application was carried out in accordance with Belzona Know-How Leaflet TCC-9.
