# BELZONA SKYLIGHT WEATHERPROOFING

ID: 187

Rainwater leakage through skylight

Large entry skylight

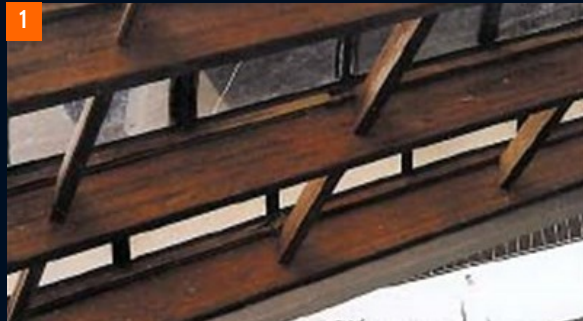
1. Water leakage was causing problems to the timbers supporting the structure.
2. Application in progress.
3. The entire 30 x 45 feet of skylight was weatherproofed.
