# BELZONA DAM LOCK SEALED

ID: 188

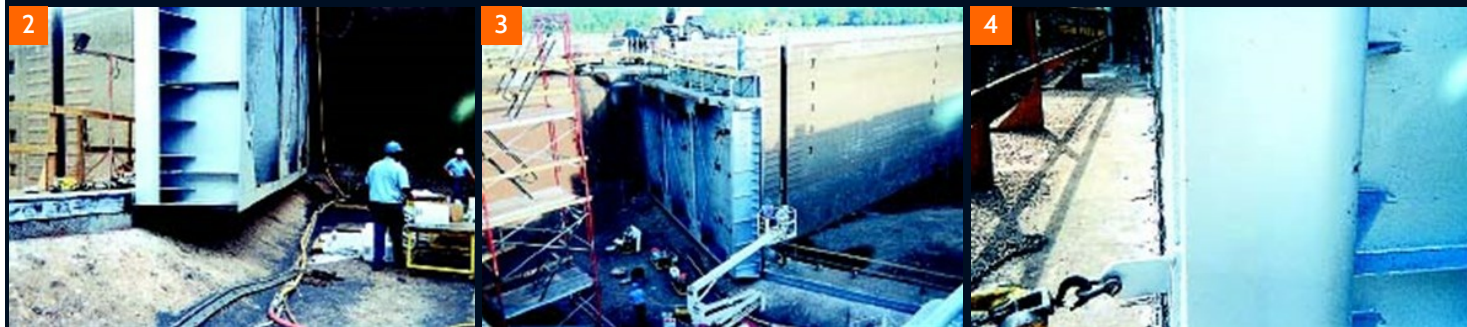
Lower seal on locks were leaking due to irregular metal-on-metal seal caused by cavitation.

1. The culprit
2. Surface preparation complete
3. Work in progress
4. The lock is sealed

Tremendous coordination was necessary between the contractor and the Army Corp of Engineers. Each door of the lock is 47 feet wide. Following surface preparation by grit blasting, product was applied to one side, TurtleWax® used as release agent to entire length of door seal.
