# BELZONA SPECIFIED BY MAJOR CENTRIFUGE MANUFACTURER

ID: 189

GHK 1250 horizontal screw centrifuge

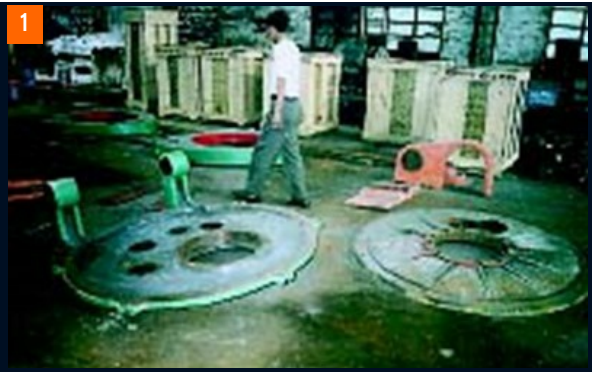
Corrosion from corn, sulfuric acid (<20%), HCL and lactic acid to contact areas including back plates, casing and inspection hole covers.

1. Surface preparation underway
2. Belzona applied to casing
3. Belzona applied to inspection hole covers
4. Completed application

Application was carried out in accordance with a modified version of Belzona Know-How Leaflets CEP-3 and CEP-10.
