# BELZONA QUICKLY RESTORES & UPGRADES TURBINE PROTECTION

A Francis turbine runner which had been previously coated 15 years ago.

Hydropower plant, France

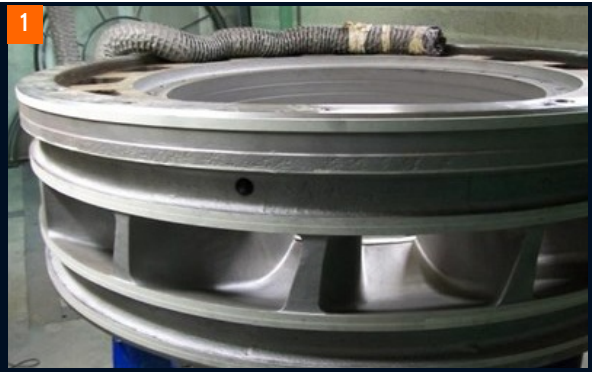
1. Blasted runner prior to the application
2. Mixing of Belzona 2141
3. Application of Belzona 2141
4. Completed equipment

Application was carried out in accordance with Belzona Know-How System Leaflet CEP-3. The bottom and top parts only needed a protection against corrosion and not erosion: Belzona® 5811 was used. The middle part had a serious problem of cavitation: Belzona® 1341 and Belzona® 2141 were used.
