# BELZONA 1591 PROTECTING COALESCER VESSEL

Coalescer vessel for installation on a Floating Oil Production and Storage vessel (an FPSO) destined for the North Sea.

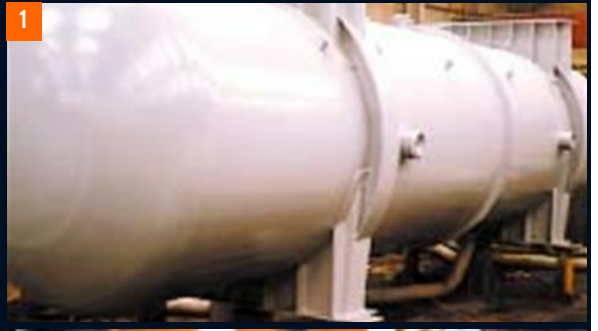
1. The Coalescer vessel.
2. Application underway inside.
3. The lower 1/3rd was protected.
