# BELZONA HEATING PIPE FITTINGS ABOARD SUPERTANKER

ID: 190

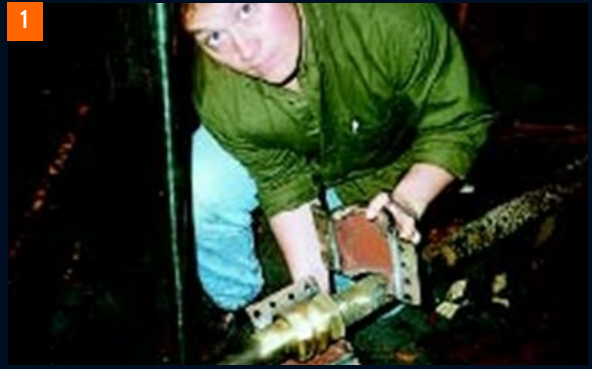
Pipe fittings continued to leak.

1. Following surface preparation, a collar was used
2. Application of product
3. Pipe fittings and sea dogs are happy with the repair

Application was carried out in accordance with Belzona Know-How Leaflet VPF-11a.
