# LONG TERM ROOF REPAIR BY BELZONA

ID: 1904

Asbestos tiled roof of an old villa.

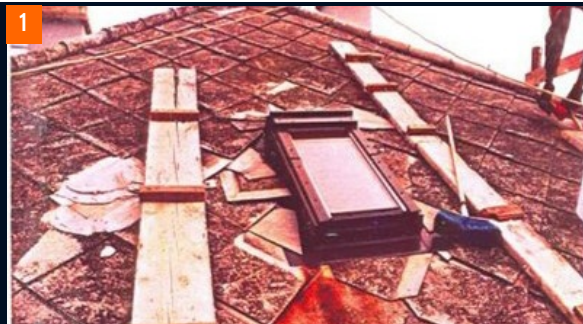
Severely deteriorated asbestos roof tiles were no longer providing weather protection.

1. Damaged roof in 1985
2. Roof application after 10 years in service
3. Close-up after 10 years in service
4. Refurbishment in 2008 again with Belzona 3111

Application was carried out in accordance with Belzona Know-How System Leaflet RPA-1.

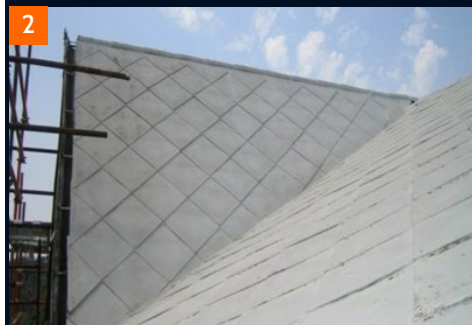
After 10 years in service, the application was reviewed and still found to be in an excellent condition. Due to the reliable performance of Belzona, the customer opted again for Belzona® 3111 to refurbish the roof after 23 years service.
