# BELZONA REINFORCES EXCAVATOR BEARING SEATS

ID: 1906

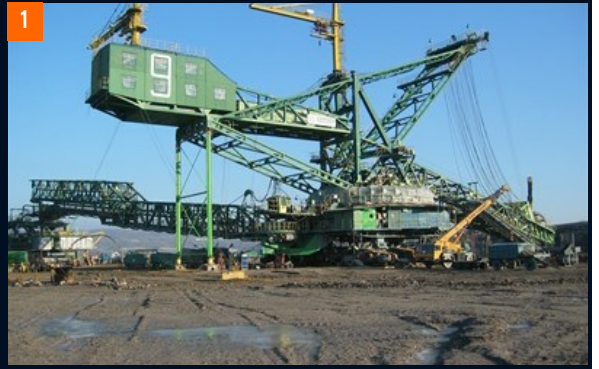
Excavator profile Bonding the plates with Belzona 1111 Preparation for injection Injection of Belzona 5811; In the diagram, Belzona 1111 is shown in blue and Belzona 5811 in beige.
