# BELZONA REPAIRS HIGHWAY UNDER THE MOONLIGHT

Rebuilding highway expansion joint nosings.

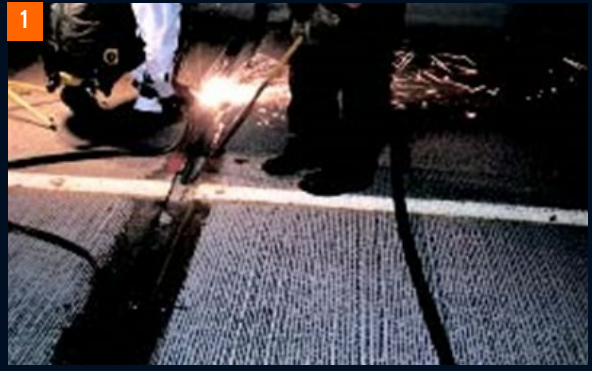
Heavy vehicular traffic over the highway caused concrete underneath the armor angle to crumble.

1. Removal of armor angle using acetylene torch.
2. Expansion joint after the removal of the armor angle. Concrete deterioration was clearly visible.
3. Styrofoam guides in place prior to application of Belzona products.
4. Belzona 4111 was force cured using pipes cut in half to contain heat from portable heaters.

The application was carried out following a modified version of Belzona Know-How Leaflet FPA-5.
