# BELZONA COMPLETES FULL REFURBISHMENT OF CHIMNEY STACK

ID: 1910

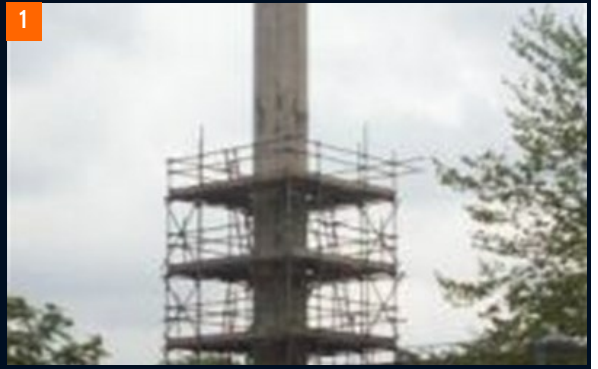
The chimney stack being scaffolded for access  
Some of the cracks requiring repair  
Close view of the chimney after the application  
General view of the completed application

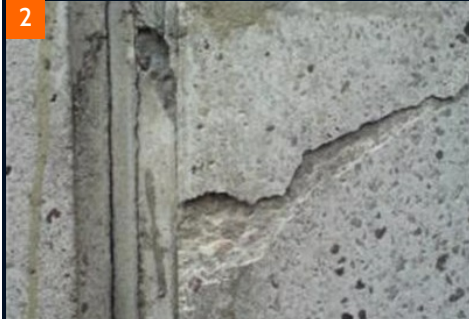
The chimney stack had several areas of spalled concrete due to moisture ingress.

Application was carried out in accordance with Belzona Know-How System Leaflets WPA-1 & 4. The areas of damaged concrete were repaired with Belzona® 4141 before the chimney stack was fully coated with Belzona® 5151.
