# LONGEVITY PUMP REPAIR WITH BELZONA

ID: 1911

Pumps used to circulate district heating water in Stockholm.

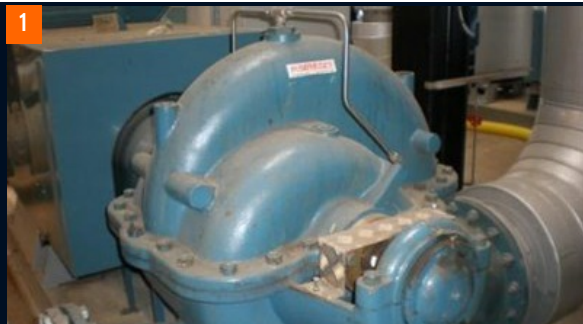
1. View of the pump
2. 3. & 4. Before cleaning after 13 years in service

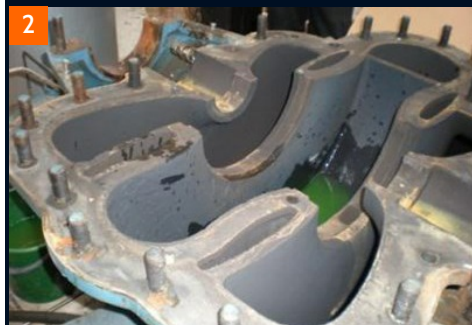
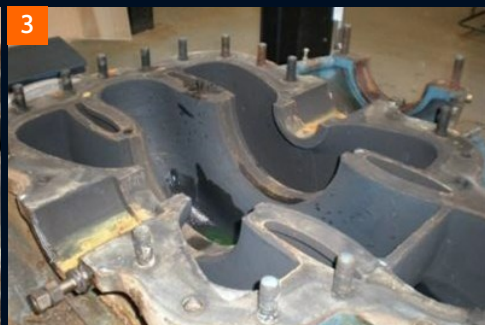
The pumps suffered from severe erosion/corrosion as they transport hot water at temperatures of 90-100 °C.

The pumps had been in continuous use to provide the southern part of Stockholm with heat. After 13 years the pump was stripped to replace a seal and the coating was still as good as new and no effects from temperature or erosion could be seen.
