# BELZONA COATING FOR A REFINERY KNOCK-OUT DRUM

ID: 1913

Low pressure flare knock-out drum measuring approximately 12 metres in length and 5 metres in diameter.

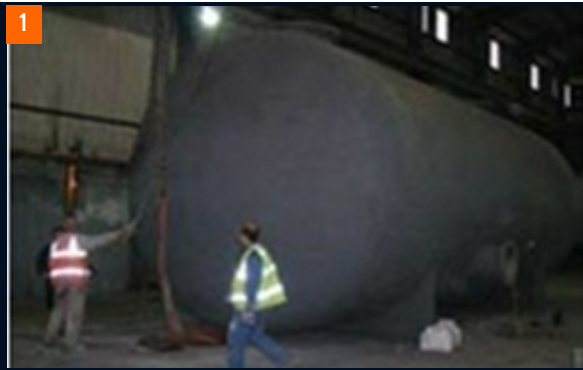
1. The vessel in the workshop
2. Smoothing the welds by grinding
3. Mixing the material
4. Spraying underway
