# BELZONA RENOVATES DILAPIDATED WATER TOWER

ID: 192

120-foot tall concrete water tower

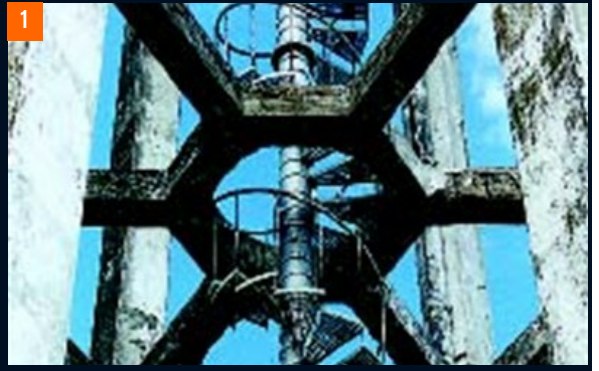
The concrete support structure and water tank was deteriorated. Pieces of concrete were falling off exposing passersby to injury.

1. Severe damage to the tower
2. Deterioration of the concrete structures
3. Application of Belzona 4141 (Magma-Build)
4. The finished repair
