# BELZONA RESTORES COAL BOXES

ID: 193

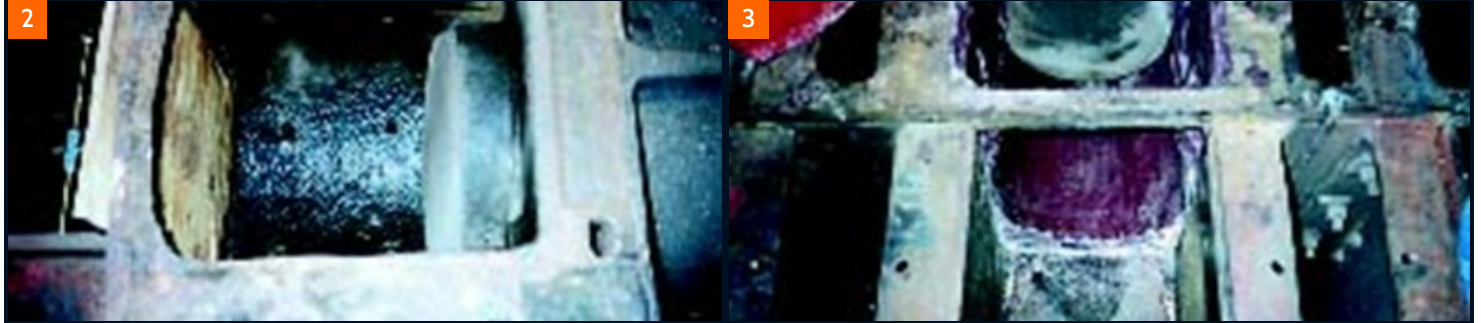
## PHOTOS

Coal boxes were worn from years of abrasion.

1. View of surface preparation of the six coal boxes.
2. Close-up of wear areas.
3. Completed Belzona 1811 (Ceramic Carbide) repair.

The application was carried out in accordance with a modified version of Belzona Know-How Leaflets SHM-13 and SHM-14.

The cost for replacing all six (6) coal boxes would have been \$21,000 plus additional installation costs. The Belzona repairs were carried out for approximately \$2,500. A one year inspection shows no signs of wear.
