# BELZONA REPAIRS 30 YEAR OLD VALVES

ID: 194

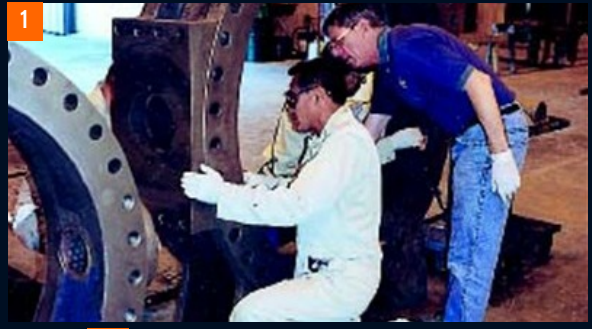
After 30 years of use, valves demonstrated severe damage from erosion-corrosion.

1. Valves being inspected.
2. Internal surfaces being protected with Belzona 1341 (Supermetalgilde).
3. External surfaces are coated with Belzona 5811 (Immersion Grade).
4. Completed valve, assembled and ready for service.
