# BELZONA REPAIRS BEARING HOUSING

ID: 195

Cement kiln-trunion bearing housing

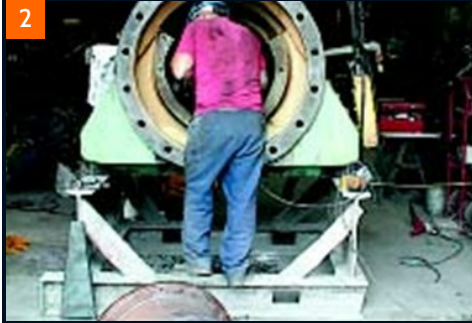
Lubrication system failed and caused severe damage to bearing housing.

1. Cement kiln
2. Surface preparation of housing with new bushing to be used as former in foreground
3. Bushing in place with Belzona 1111 (Super Metal)
4. Reformed bearing housing

Application was carried out in accordance with a modified version of Belzona Know-How System Leaflet MPT-2.
