# BELZONA EXPANSION BELLOWS REPAIR AT POWER PLANT

ID: 196

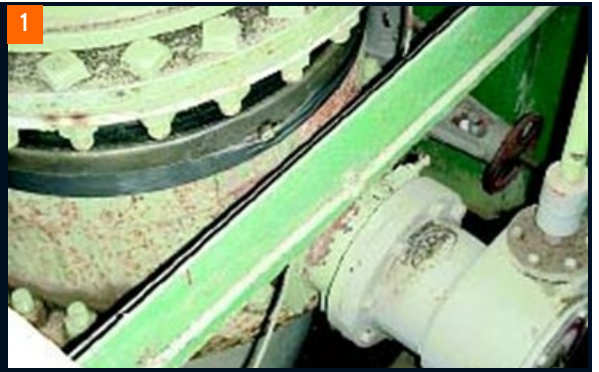
1. Expansion bellows after application of Belzona 2911
2. Belzona 2111 being applied to the surface of expansion joint
3. Finished repair

Use of Belzona® 2111 (D&A Hi Build Elastomer) allowed the expansion joint to be repaired for less than \$2,000.
