# BELZONA STOPS METHANE LEAK

ID: 198

Cracks in top of methane tank

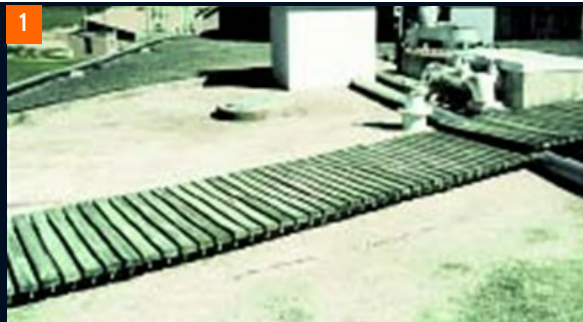
The 30-year-old tank had cracks and pin holes allowing methane gas to escape.

1. Top of tank with cracks and pin holes
2. After cleaning tank, Belzona 4111 was used to fill cracks
3. First coat of Belzona 5811 was applied
4. Belzona 5811 (black and beige) were mixed to a grey color and applied for the second coat
