# A BELZONA SOLUTION THAT HOLDS WATER

ID: 199

A two-level fountain

The University of Iowa, U.S.A.

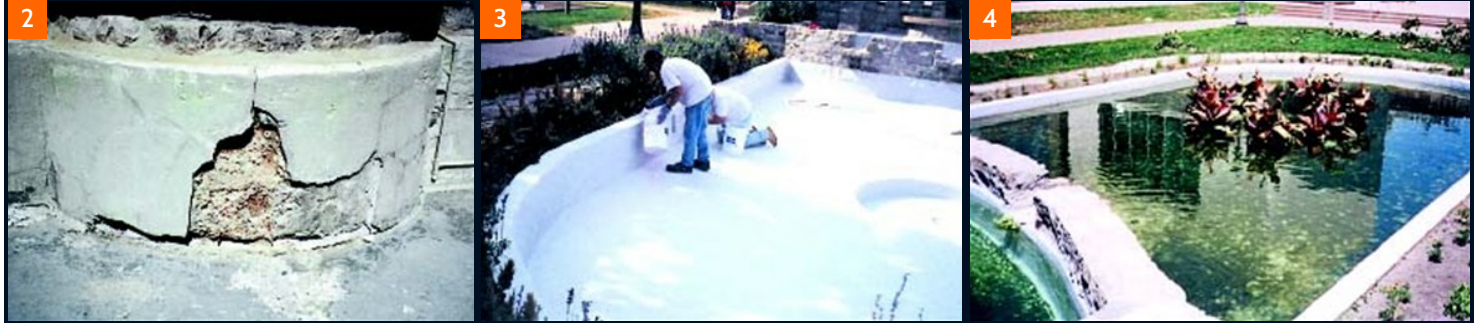
The concrete and stone base was badly damaged with a large number of cracks and hollowed areas. Water was leaking into underground service tunnels. Previous repairs did not last for more than one year.

1. Overall view of the fountain
2. Badly damaged concrete in the wall of the upper portion of the fountain
3. Putting the finishing touches on the lower fountain area
4. The fountain during 1999 - still trouble free

The Application was carried out out in accordance with Belzona Know-How System Leaflets FPA-1, TCC-9, RPA-6 & RPA-11.

Inspection of the fountain in late 1999 revealed that the Belzona repairs were performing as anticipated. The fountain was donated to the university by the class of 1936.
