# BELZONA 2000 SERIES ELASTOMERS FOR SWIMMING POOL EXPANSION JOINTS

ID: 201

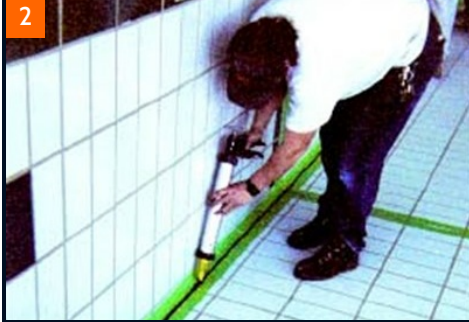
1. General view of the facility
2. Injecting the Belzona 2221 (MP Fluid Elastomer) into the expansion joints
3. View of the completed pool

The application was carried out in accordance with a modified version of Belzona Know-How System Leaflet FPA-6.
