# BELZONA 4111 MAINTAINS SAFE FACTORY ENVIRONMENT

ID: 202

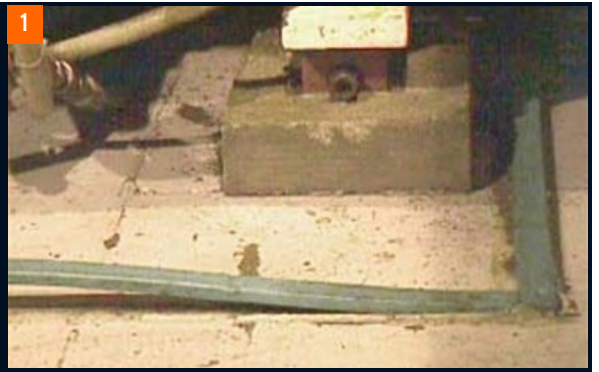
1. Former being positioned
2. General view of machines with formed bunds
3. Close-up of the formed bund

Three inch plastic half pipes were used to form the Belzona® 4111 thereby creating a bund or containment area around each machine. The Belzona application has withstood heavy duty use and is resistant to the various oils and chemicals in use. The application also has helped to satisfy hygiene inspectors previously concerned with floor contamination.
