# BELZONA 4131 REPAIRS TO SPALLED CONCRETE

ID: 203

Canopy over a busy shopping area

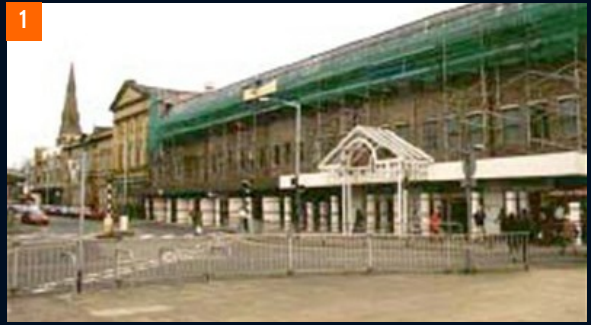
1. General view of the site with specially boarded up Acrows insisted on by safety officials
2. The degree of concrete damage clearly evident
3. Rebuilding complete and gutter re-instated

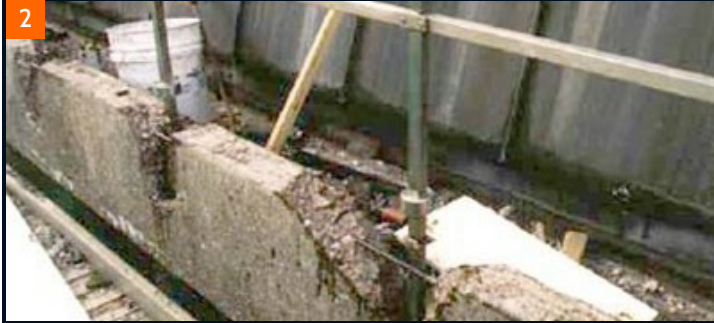
Extensive spalling had made using the hand-rail unsafe.

When work initially started damage was found to be more extensive than originally thought. Old railings were replaced. Rapid repairs with Belzona® 4131 ensured minimum disruption.
