# BELZONA SEALS SWIMMING POOL LEAKS

ID: 205

Expansion joints in swimming pool

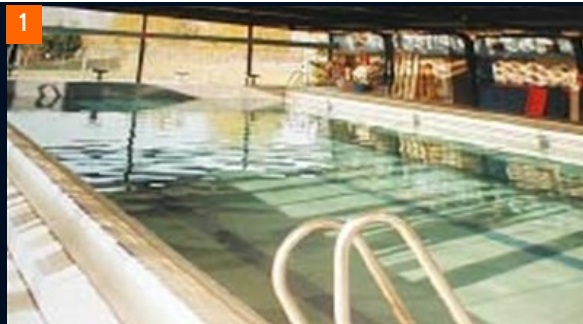
The original Silicone sealant had deteriorated allowing large water losses.

1. General view of the pool
2. Joint nosings rebuilt with tinted belzona 4111
3. Joint being masked prior to sealing with Belzona 2211
