# BELZONA 6111 PROTECTION OF FIRE HYDRANTS

ID: 206

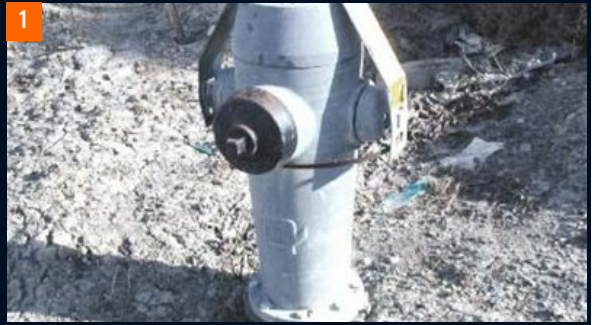
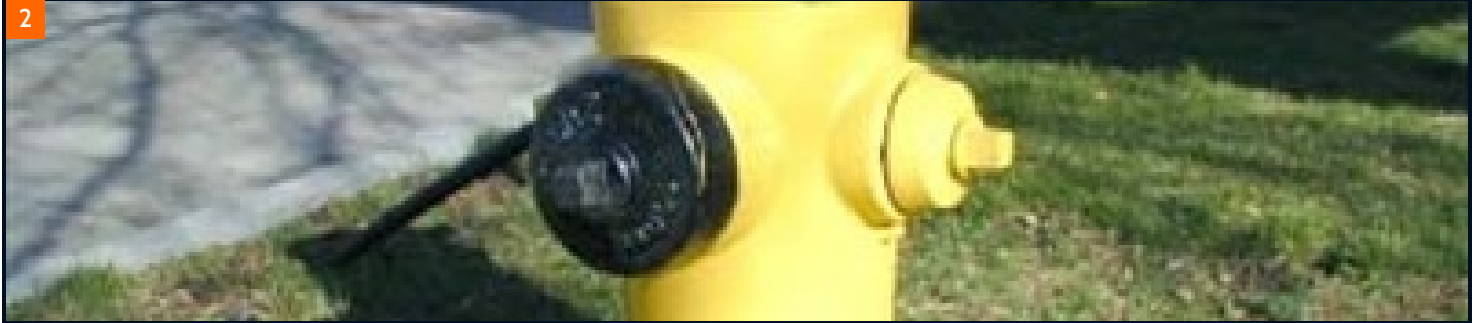
## PHOTOS

Ineffective primers used during manufacture led to repetitive painting. Road salt and grit during severe winter conditions accelerates corrosion.

1. Hydrant with Belzona 6111 applied
2. Completed application with top coat of paint applied

Application carried out in accordance with a modified version of Belzona Know-How System Leaflet TCC-5, before overpainting with required color top coat.

Customer carried out tests and found Belzona® 6111 to be the most effective system. Previous annual painting has been extended beyond five years.
