# BELZONA REFURBISHES SCRUBBER RUBBER

ID: 207

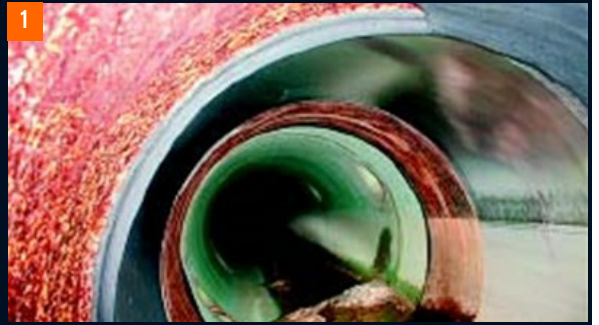
Rubber lining on a scrubber unit was worn away leaving carbon steel exposed.

1. Application begins
2. Application continues
3. Close-up view at a repaired area

The application was carried out in accordance with a modified version of Belzona Know-How System Leaflets SHM-8 and SHM-9.
