# BELZONA PROTECTS EXHAUSTER FAN

ID: 208

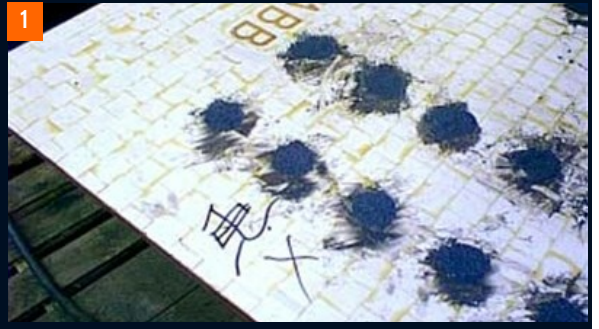
The mounting holes are normally covered with a tile insert, but these came loose, exposing bolt to abrasion and failure. The spokes of the fan are also exposed to abrasion.

1. Belzona 1812 applied to seal bolts
2. General view of the fan
3. Belzona 1811 applied to fan spokes
