# BELZONA 1341 IMPROVES SWIMMING POOL PUMP PERFORMANCE

ID: 2084

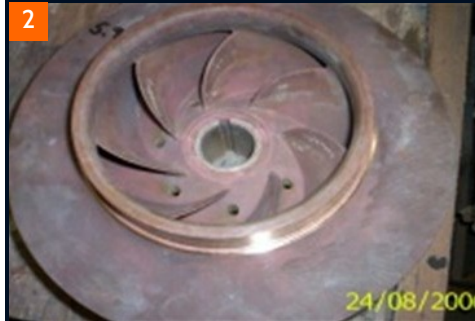
Erosion corrosion, aggravated by galvanic corrosion and corrosion from pool chemicals had reduced pump performance.

1. Pump casing prior to application
2. Impeller prior to application
3. Pump casing after application of Belzona 1341
4. Pump impeller after application of Belzona 1341

Apart from the general erosion corrosion problems experienced with swimming pool pumps, improving pumping efficiency and reducing running costs were becoming more important as energy costs continue to escalate. An application of Belzona® 1341 Supermetalgilde to the internal surfaces of the pump increased the efficiency by almost 12%.
