# BELZONA SEALS ACCESS RAMP LEAKS

ID: 2086

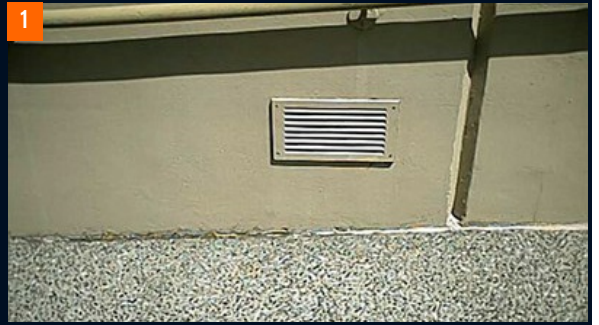
The caulking between the walls and ramp base needed to be replaced on a regular basis to prevent water from entering into the area below.

Water was entering the storage and equipment areas below.

1. View of joint to be sealed
2. Application of 1st coat of Belzona 3111 incorporating Reinforcement Sheet
3. Completed application
