# A LEAK SEALING SOLUTION WITH BELZONA

ID: 209

Stainless steel absorber vessel and agitator

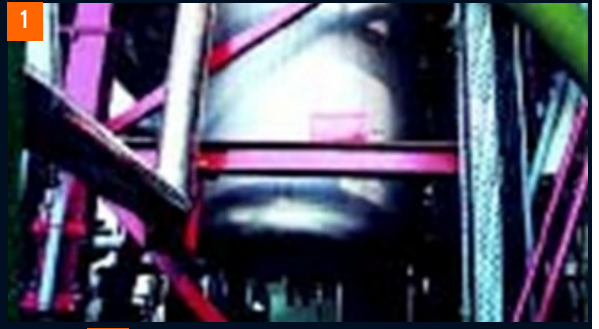
Leaks from chemical attack and galvanic corrosion. Chemicals included 30% concentrated sodium hydroxide, 65% concentrated sulphuric acid and 30% concentrated hydrochloric acid.

1. Stainless steel absorber vessel and agitator - general view
2. Applying Belzona 1111 (Super Metal) to problem areas
3. Applying Belzona 4341
4. Protected agitator ready for service
