# BELZONA PROTECTS STRIPPER TOWER

ID: 21

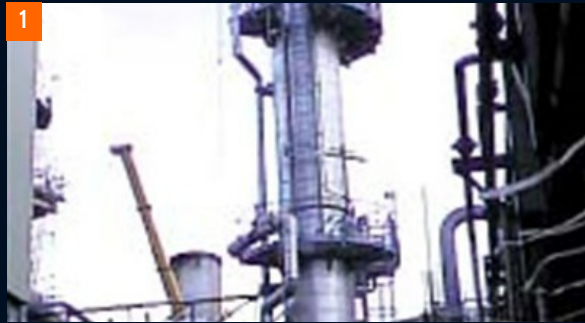
Erosion/corrosion caused by steam together with chlorides and other impurities.

Original glass flake lining failed and protection required to keep the tower in service to next major shut-down.

1. General view of the Stripper Tower
2. Application underway in the confined space of the Tower
3. Application continues
