# BOILING WATER: NO PROBLEM FOR BELZONA 4181

ID: 210

Hospital kitchen floor

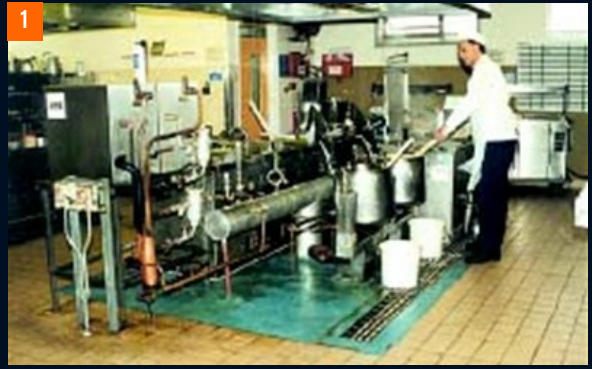
Boiling water had broken down an existing epoxy coating and the underlying concrete floor it was supposed to protect.

1. General view of floor problem area
2. Close-up of damaged area around drainage channel
3. Belzona 4181 application underway
4. The finished application
