# BELZONA PROTECTS NEW STAINLESS STEEL CONES

ID: 213

Transition cones from conveyor belts to coal pulverizers.

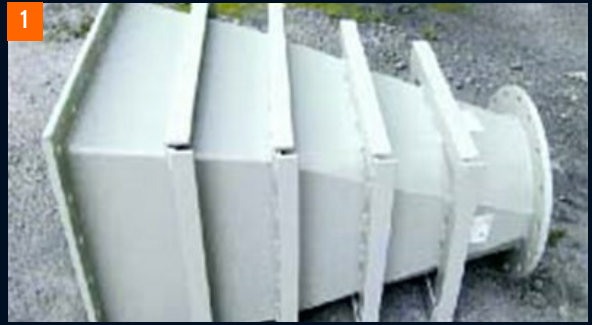
Impact and abrasion from coal, coupled with high temperatures caused severe wear to the cone walls.

1. New cone prior to application
2. Blasted cones
3. Protected cone with Belzona 1812 that is ready for service

The application was carried out in accordance with Belzona Know-How System Leaflet SHM-13.
