# BELZONA PROTECTS WELD SEAMS IN RECYCLING DRUM

ID: 214

Recycling drum used to process waste paper for use in newspaper.

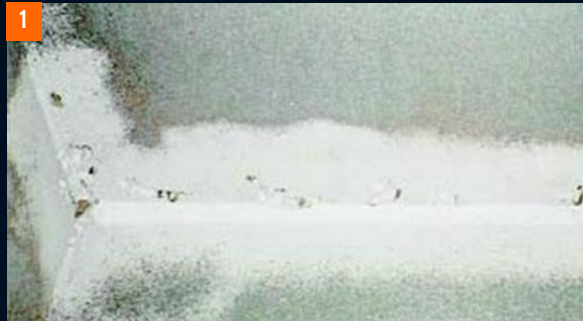
The debris settles in the 90 degree angles of the weld seams. The 60°C (140°F) environment with a pH 10 leads to galvanic and crevice corrosion of the weld seams.

1. Weld seams after grit blasting
2. Work in progress applying Belzona in the drum
3. Some of the completed repairs

The application was carried out in accordance with Belzona Know-How System Leaflet TCC-5.

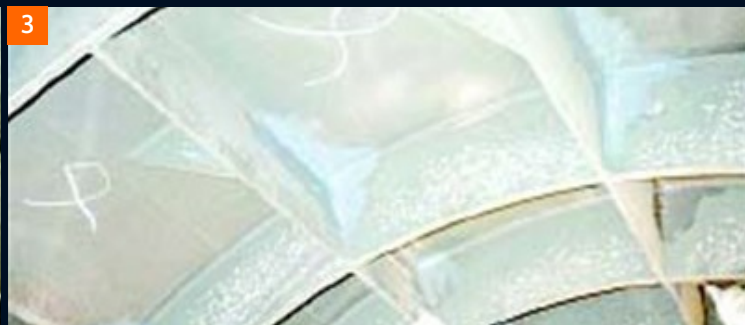
The Belzona repair was inspected in April 2000 and there were no signs of wear, breakdown or further corrosion.
