# BELZONA RESTORES CRITICAL TOLERANCES IN LIQUID RING VACUUM PUMP

ID: 2154

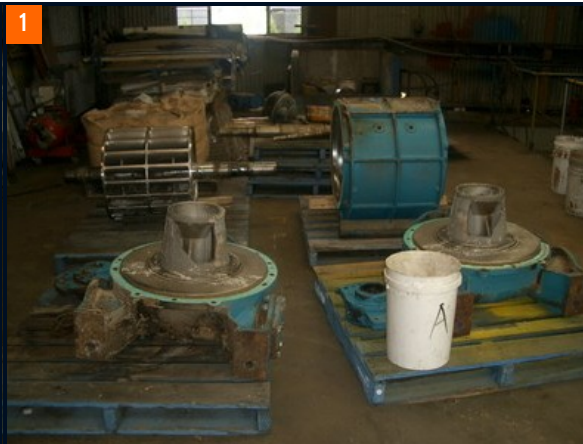
1. A dismantled vacuum pump from Paper Mill
2. Cone from 14,000 CFM vacuum pump undercut prior to the application
3. The stainless steel cone repaired with Belzona 1111 after 4 years in service
4. The stainless steel rotor is showing significant wear, whereas the Belzona 1111 applied to the adjacent cone is not

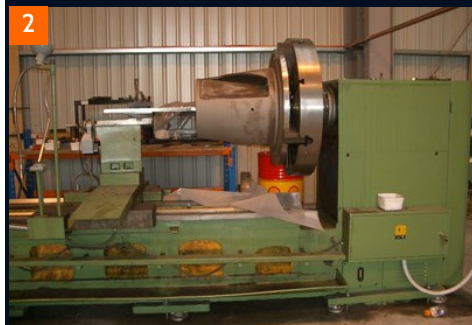
The pump is subjected to corrosion and “carry over” of the paper pulp. The tolerance between the outside diameter of the cone and the internal taper of the rotor was no longer correct, due to the wear on the cone flange, clearly visible near the bolt holes.

Application was carried out in accordance with Belzona Know-How System Leaflet FBC-10. The stainless steel cone in this pump was rebuilt with Belzona® 1111 and machined to correct dimensions and taper angle.

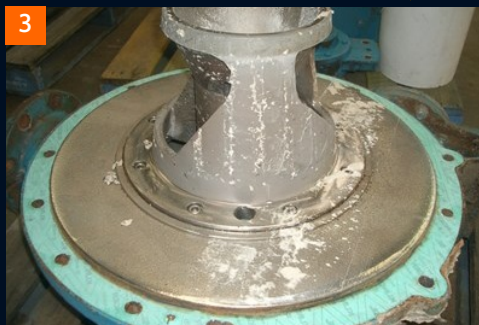
The pump cone was inspected after 4 years in service. Despite the aggressive conditions, the Belzona® 1111 is showing virtually no wear. The stainless steel rotor is showing significant wear whereas the Belzona® 1111 applied to the adjacent part (the cone) is not.
