# BELZONA COMBATS A MAJOR VACUUM PUMP WEAR PROBLEM

ID: 2156

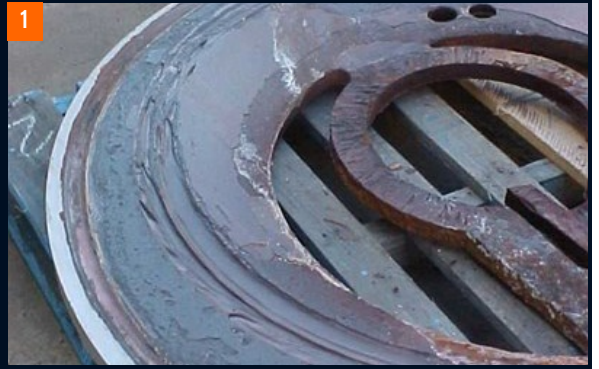
A pump was removed from service and inspected. On dismantling the pump, it was found that excessive “carry over” from the process had caused major erosion and corrosion damage to the pump components and the critical tolerances had been lost.

1. Worn port plate
2. Worn head
3. Port plate completed
4. Rotor completed
