# BELZONA SAVES REPLACEMENT COSTS

ID: 216

Universal joint between power unit and trailer of articulated earth mover.

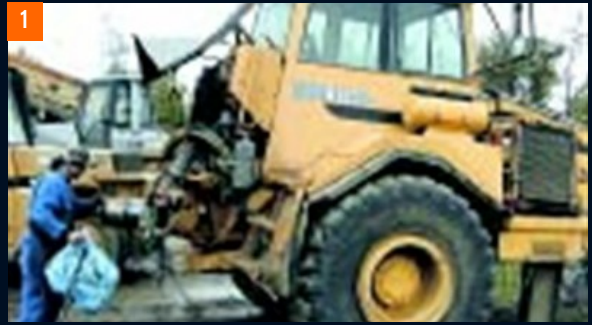
The ends of the shaft were worn due to play in the joint.

The power unit The damaged shaft  
Application of the Belzona 1111 underway  
The completed repair

The application was carried out in accordance with Belzona Know-How System Leaflet MPT-1.
